# ASSESSMENT OF COMMUNITY TOILETS AND PUBLIC TOILETS IN PERIYANAICKEN-PALAYAM AND NARASIMHANAICKEN-PALAYAM TOWN PANCHAYATS OF COIMBATORE

April 2018

In all the 25 facilities, a condition assessment study was done using a structured questionnaire to understand various aspects of their physical infrastructure: super structure and sub-structure of the toilet blocks; water and electricity supply; solid waste, wastewater disposal facilities and drainage; management and maintenance arrangements & practices. Inputs from visual inspection and from caretakers were also recorded.

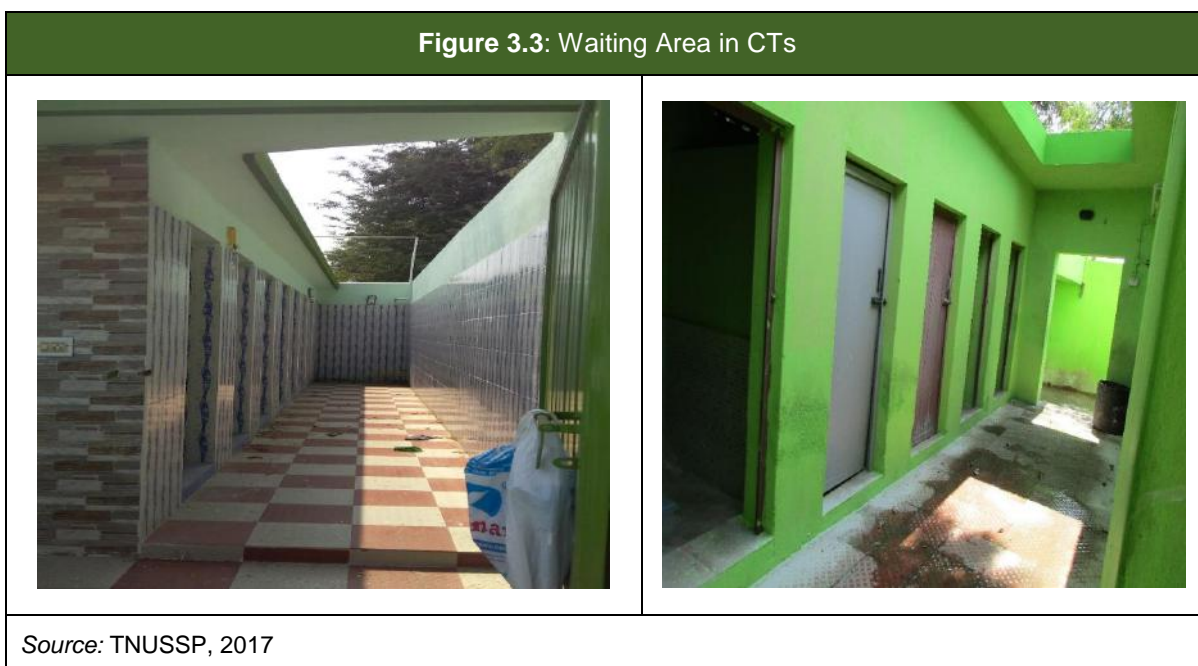
All the 23 CTs were single-storeyed buildings with a carpet area ranging from 10.95 square metres (sq m) to 203.4 sq m, with an average area of 75 sq m ( $\sigma = 57.54$ ). Having a waiting area was particularly relevant during peak hours, when the people needed enough space to stand/queue to use the facility. Fourteen facilities had waiting areas, of which five facilities had them for both men and women. The mean waiting area for women was 26.48 sq m, while that for men was 18.31 sq m. The distribution of waiting area by gender is presented in Table 3.2 and actual image in Figure 3.3.

All CTs were built with a Reinforced Cement Concrete (RCC) roof, tiled floors in 74 per cent of the facilities, and in 95 per cent of cases, tiles were used up to 4 feet dado level. *As per the SBM norm, an adequate circulating area should be provided – usually 2-3 m wide, depending upon the land area available.* The circulating area should be kept open to the sky as far as possible to allow for fresh air and sunlight. All the CTs were given provisions for adequate ventilation and 96 percent of CTs had plenty of natural light within the enclosures.

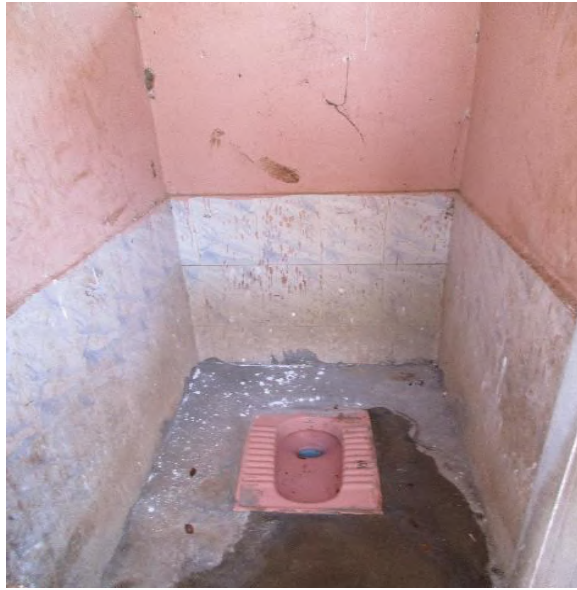
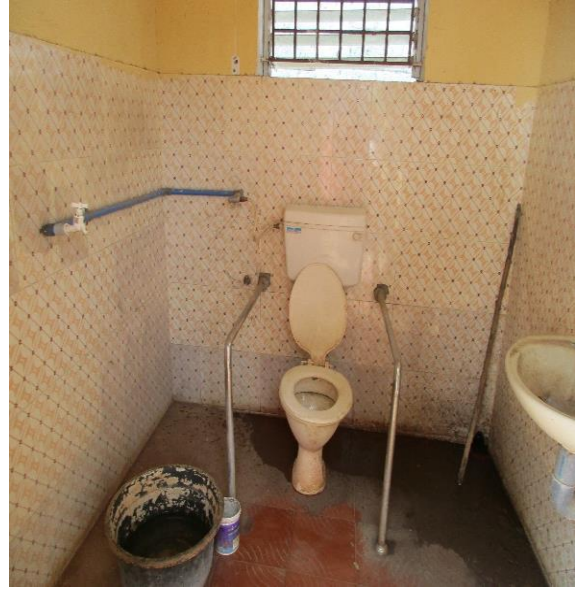
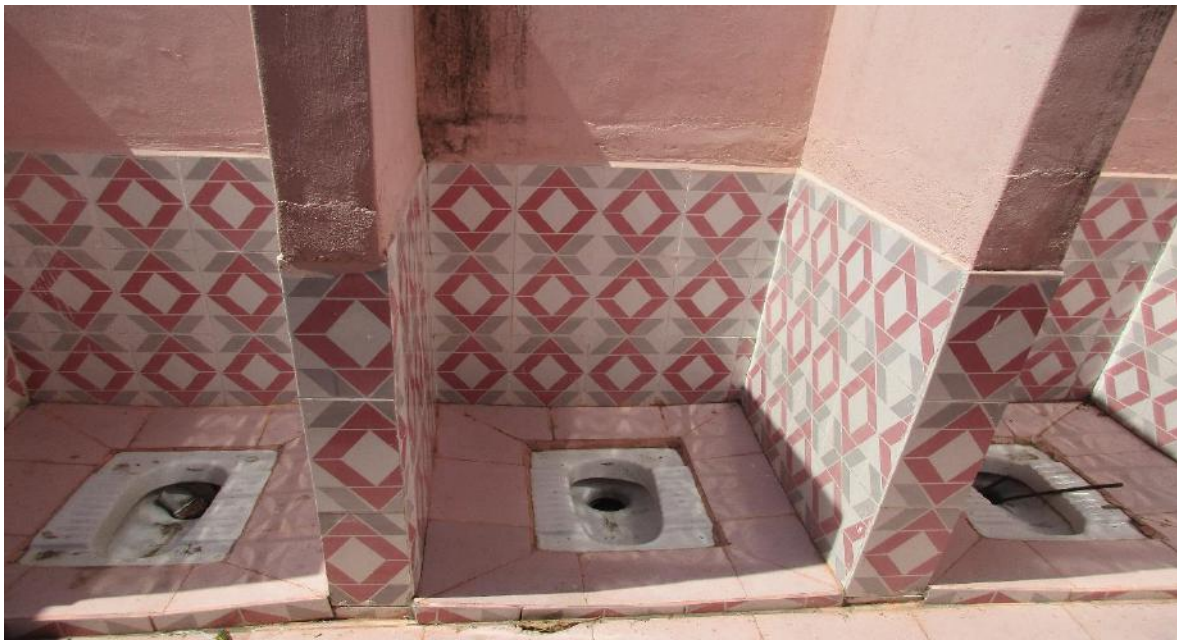
**Figure 3.4: Push Flush Toilets in PNP and NNP**

In the 23 CT facilities, there were a total of 244 seats (in Table 3.3), 46 of which were in the four non-operational CTs (38 of which are in NNP). Of the existing seats, 44 per cent were for men, 51 per cent were for women, and the rest were for children (2 percent) and those with physical disabilities (one per cent). Pour flush was the main type of toilet in all the facilities, with squatting pans being the predominant arrangement (Figure 3.4). The only facility to have dedicated seats for children was in NNP, which was, however, non-operational. Access to toilets in most cases was through steps, except in the case of facilities with toilet seats for persons with disabilities, where both a ramp and steps were available. The mean plinth height of the toilet block from ground level was 410 mm, which is within the recommended range of 300 mm to 600 mm.

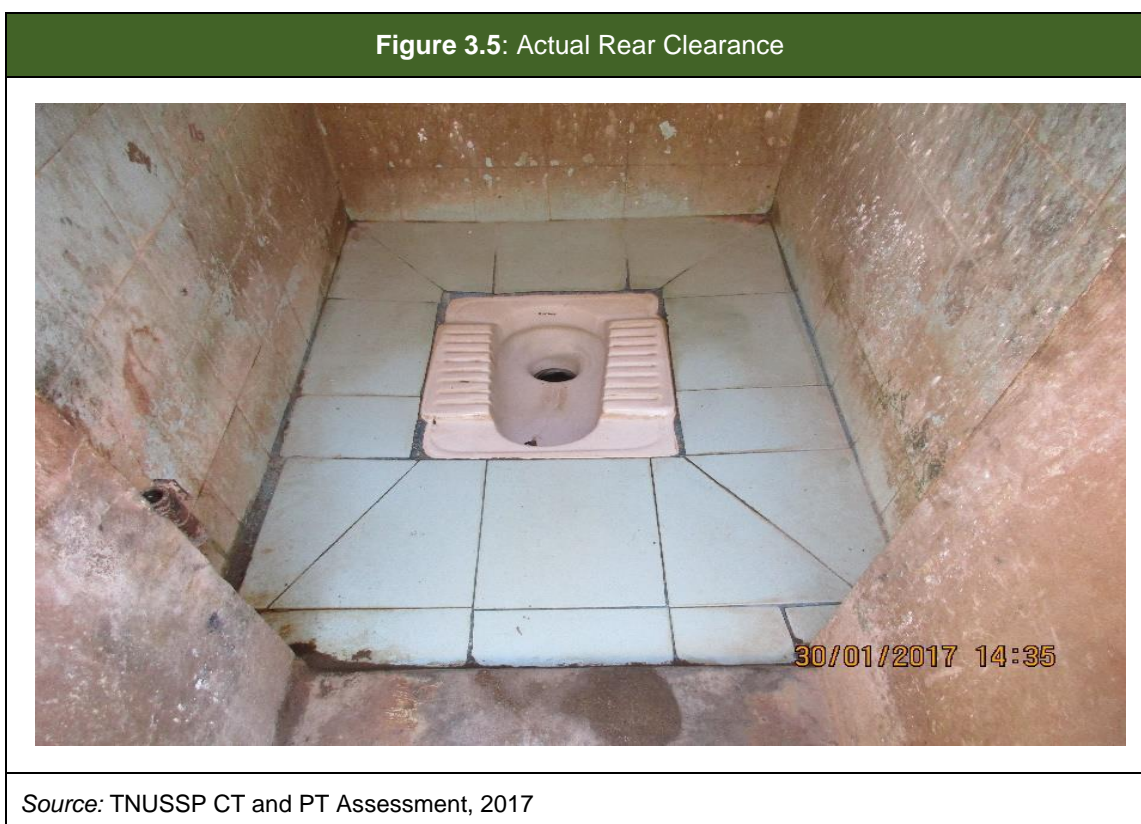
Squatting pans made of porcelain with footrests were found in all the CTs. For the comfort of the users, a minimum clearance of 200mm is recommended from the rear edge of the pan to the back wall of the super structure of 200 mm. This rear clearance requirement was met in all female toilets and all male toilets except one (Figure 3.5). Pan traps were also found in all the CTs.

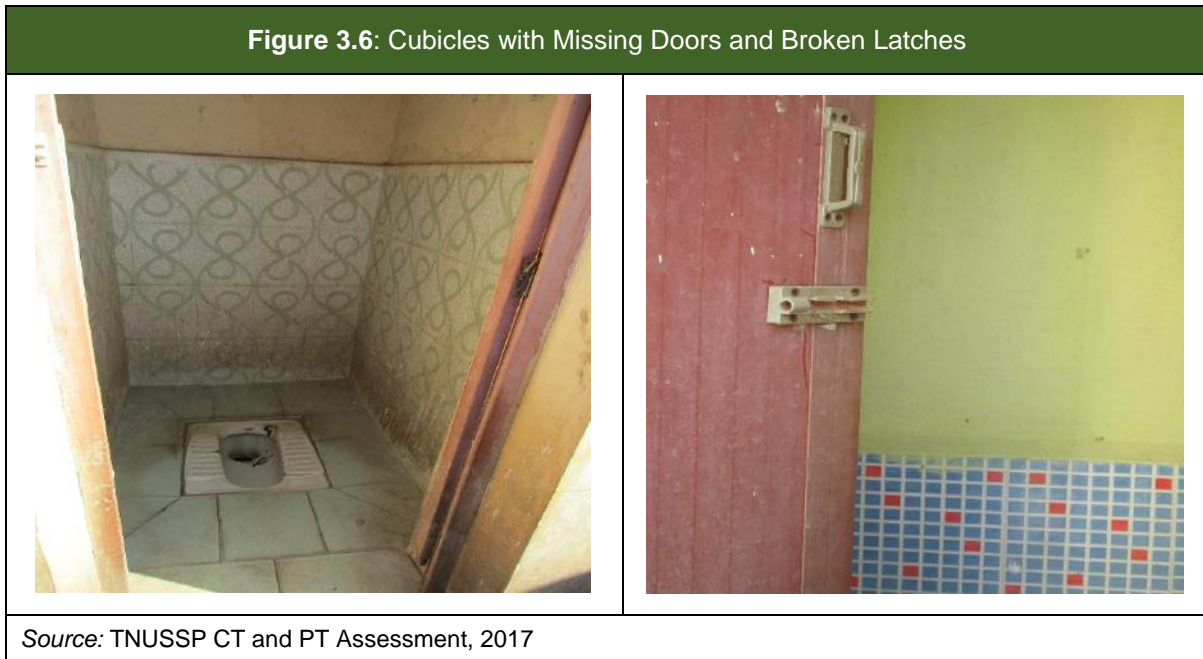
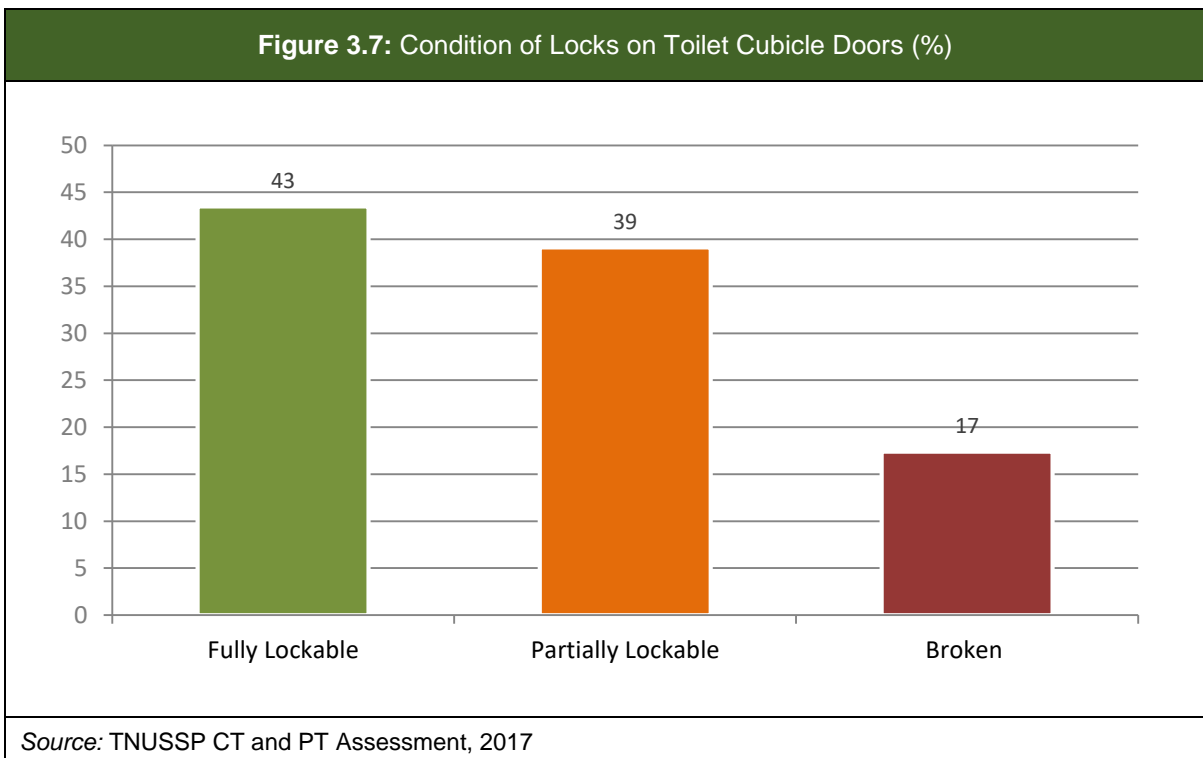
User privacy, which is central to comfortable use of the facility, was an issue, with 39 per cent of the CTs not having doors for individual cubicles (Figure 3.6). Wherever doors were available, PVC was the main material (61 per cent) used, followed by steel (23 per cent), while in some facilities a mix of materials was used. Further, even if the doors were present, latches were fully lockable in just 43 per cent of facilities, while in 39 per cent of the cases they were partially lockable and in 17 per cent they were all broken (Figure 3.7).

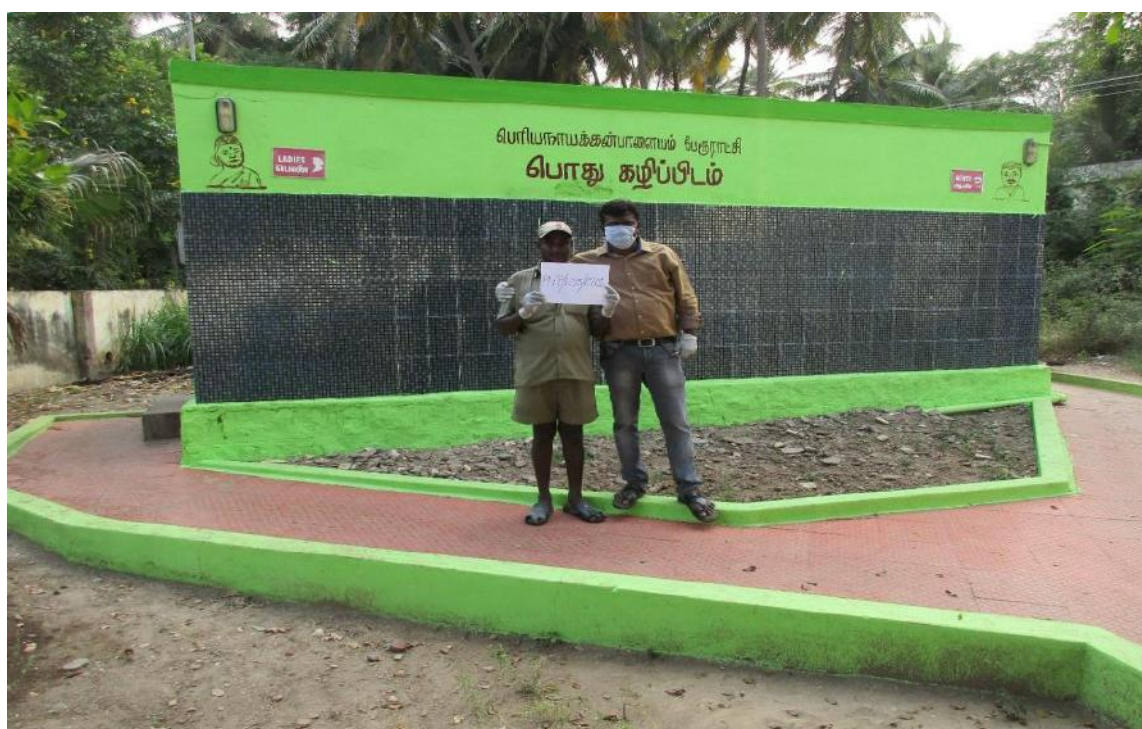
Figure 3.8: Signage for Male and Female Sections in PNP

Separate entrances for men and women were noted in all the 20 facilities where relevant<sup>4</sup> (Figure 3.8), while signages were present only in 90 per cent of the facilities. The mean height of the partition wall was 2.14 m and width was 2.74 m, which was adequate for privacy. Around 61 percent of CTs had a compound wall with a mean height of 1.09 m, while three of them reported different heights of compound wall for the women's section (1.77 m mean height).

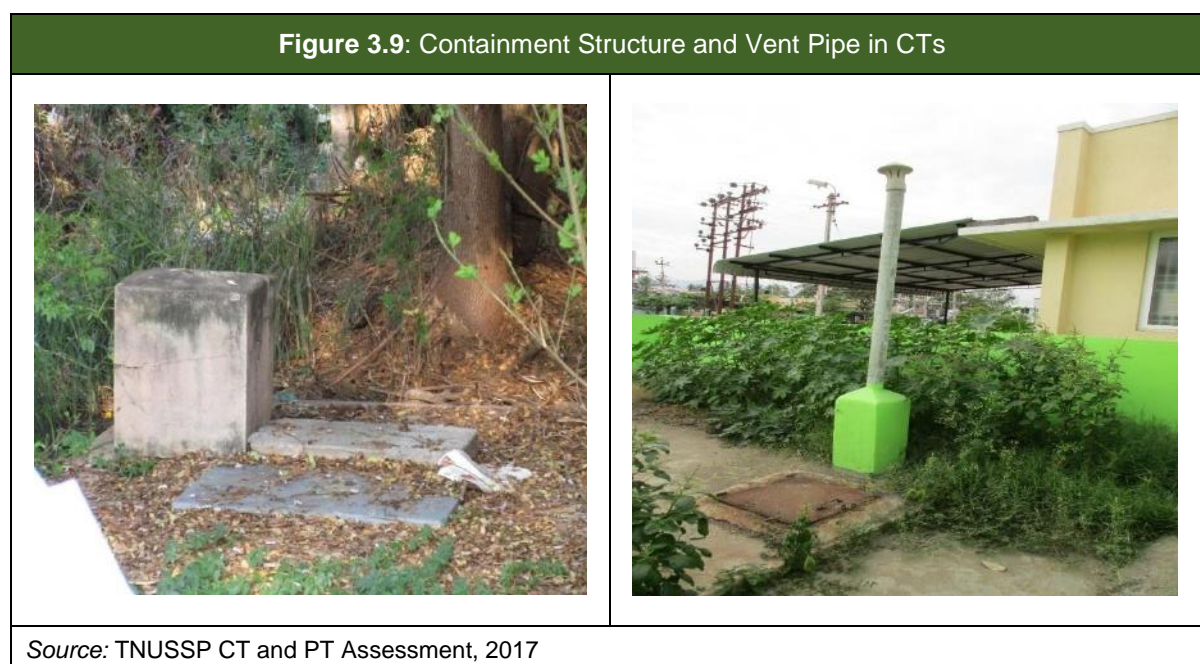
All the CTs had a septic tank, located mainly in front of the toilet (43 per cent), behind the toilet (34 per cent) and on the side of the toilet (22 per cent). In 61 per cent of the CTs, septic tanks were completely below ground level, and in the rest of the cases they were partially below ground level (Figure 3.9). Manholes ranging from two to six in number were noted in 91 per cent of the facilities.

The average distance of the containment from the toilet is 1.98 m (range: 0.51 m to 8.55 m). Complete dimensions of the septic tanks could not be measured because of the lack of information on depth. Tanks were, however, not designed as per standards and lacked features such as baffle walls or connection to a soak-pit. Although 83 per cent of CTs had a vent pipe, it was broken in nearly half of the facilities that had them. The mean height of the vent pipe was 2.69 m and two facilities did not have a fly screen. One facility in Sakti Nagar in PNP had been closed because the visual exfiltration had inconvenienced the neighbours. In 91 per cent of the 23 facilities, grey water was separated from black water – in 57 per cent of the cases it was drained into stormwater drains while in rest of the cases, it was let out into open fields.

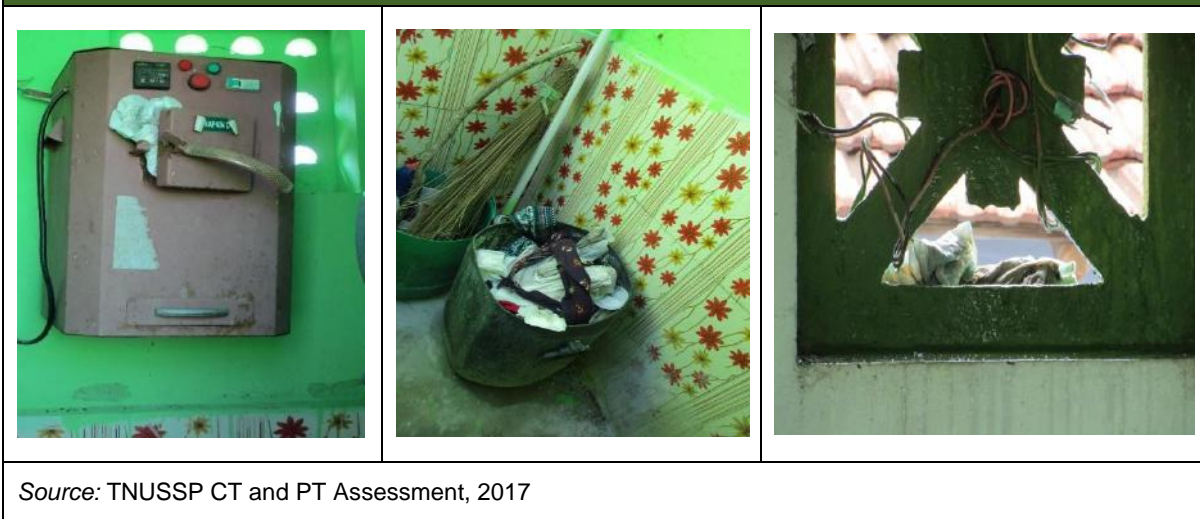
**Figure 3.10: Arrangements for Menstrual Waste Disposal**

Just three of the 23 facilities had a waste bin, although without signage. Incinerators were found in three facilities, but not in those CTs exclusively for women (Figure 3.10). Further, the incinerators in these facilities were not in working condition. Menstrual waste was often found dumped on window sills or on the roof, rather than disposed off properly and safely.

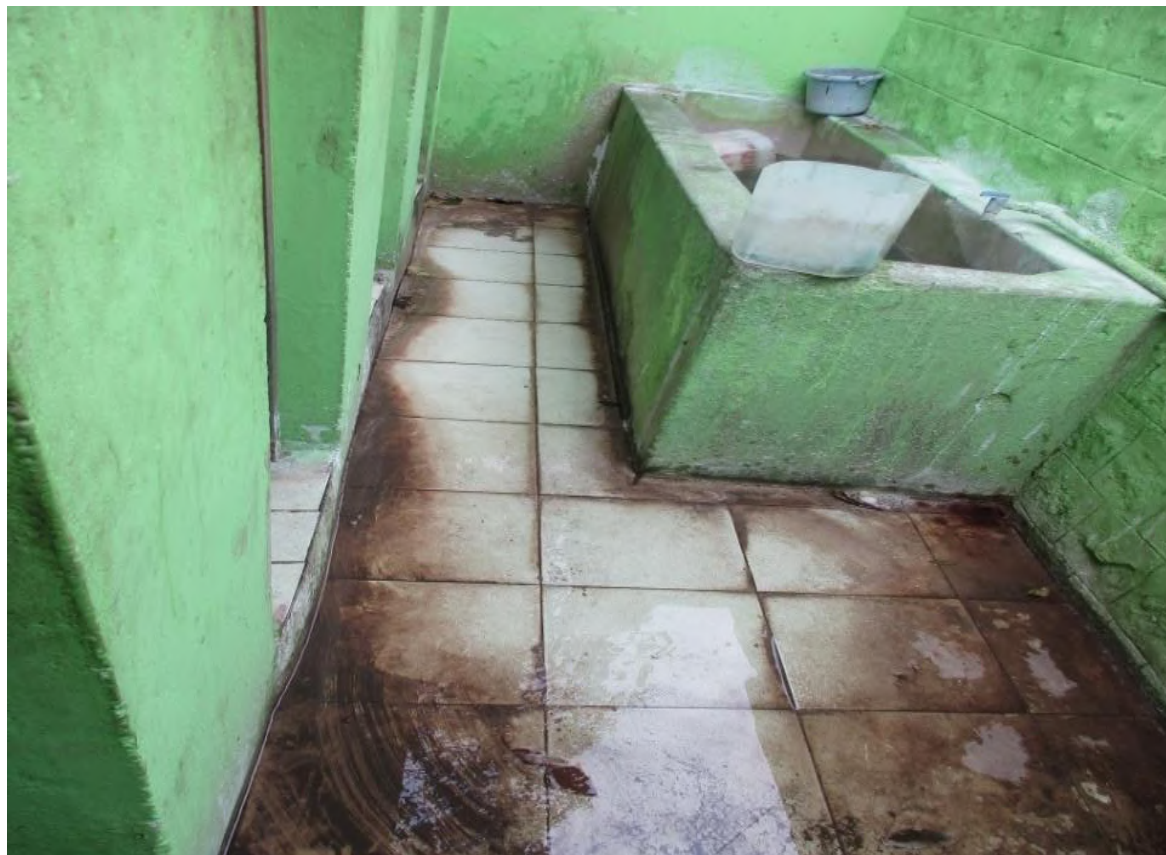
Figure 3.12: Water Storage Tank in a CT

As per the norm, if water is to be drawn from the municipal supply, an underground reservoir of half a day's capacity and an overhead tank with half a day's capacity and pumping arrangement with a standby pump have to be provided. Of all the facilities, 23 had storage tanks and two facilities had overhead tanks. The mean size of storage tanks was found to be 1,900 l (ranging from 540 l to 5,033 l) for men's sections and 2,560 l (ranging from 440l to 9,460 l) for female sections. However, there was no correlation between the storage capacity and the number of seats. In a majority of the facilities, the tank was filled up more than once.
