BASELINE STUDIES: TIRUCHIRAPPALLI, PERIYANAICKEN-PALAYAM, NARASIMHANAICKEN-PALAYAM

December 2016

This document is produced as part of Tamil Nadu Urban Sanitation Support Programme (TNUSSP). TNUSSP supports the Government of Tamil Nadu (GoTN) and cities in making improvements along the entire urban sanitation chain. The TNUSSP is being implemented by a consortium of organisations led by the Indian Institute for Human Settlements (IIHS), in association with CDD Society, Gramalaya, and Keystone Foundation.

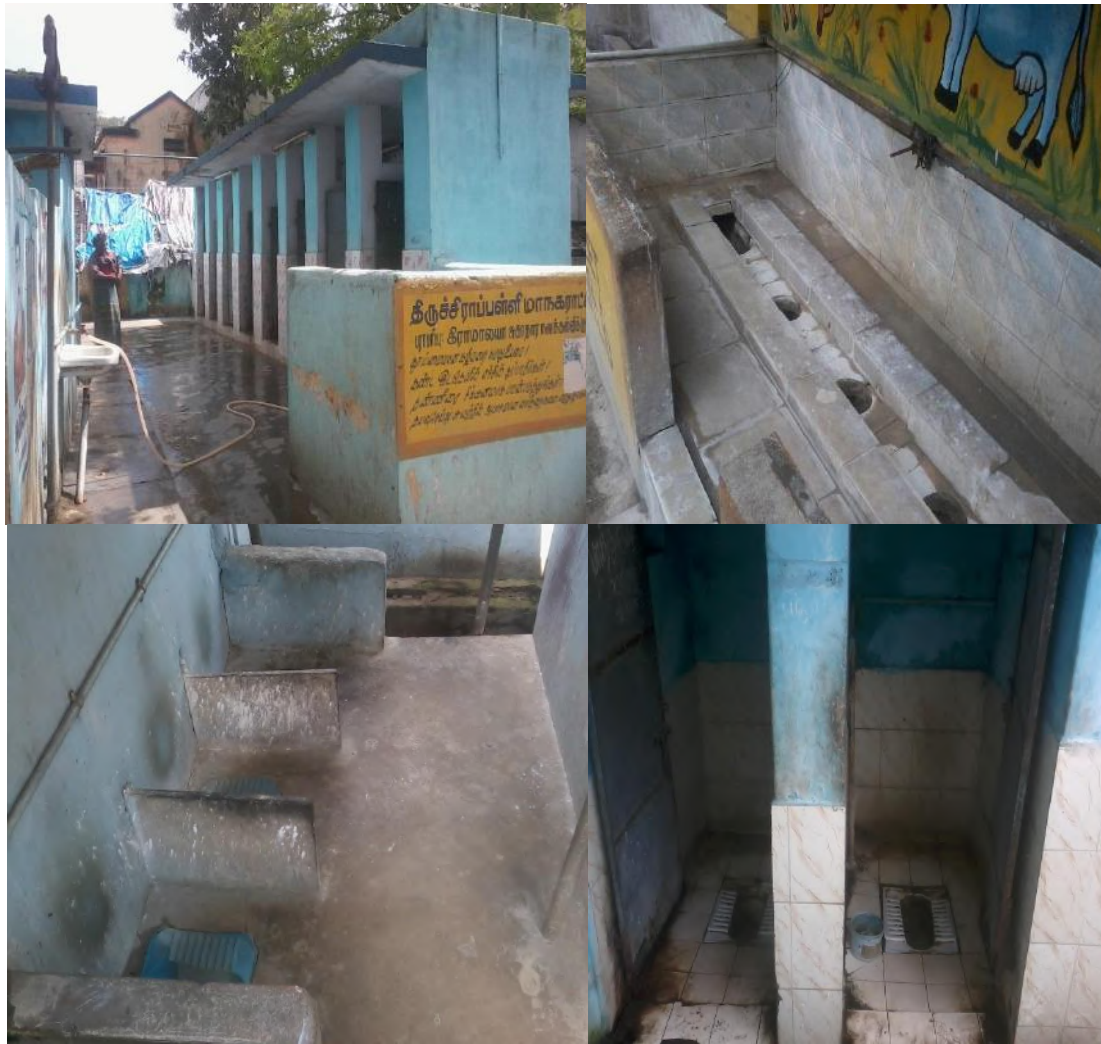
Figure 3.2: Community toilets in Tiruchirappalli

The number of toilets across CT/PTS ranges from 5 to 10 with same number of toilet rooms for women and men. CT/PTs run by Corporation and WAVES had separate toilet rooms for the differently-abled (with only the latter offering ramp access to disabled persons) and CT/PTs run by Corporation and private organisations offer bathing facility also. Every day on an average 250 men and 180 women use CT/PTs, across corporation, WAVES, and NGO run CT/PTs. Private CTPT, report 250 men and 50 women using their toilets on a daily basis.

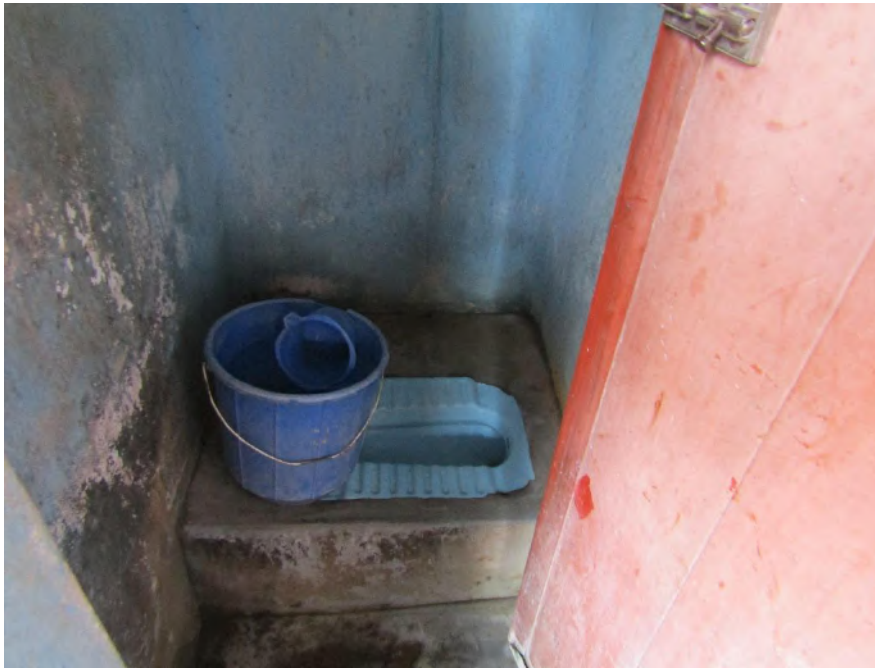
Figure 3.3: Community toilet showing small plinth area

The number of toilets across CT/PTS ranges from 5 to 10 with same number of toilet rooms for women and men. CT/PTs run by Corporation and WAVES had separate toilet rooms for the differently-abled (with only the latter offering ramp access to disabled persons) and CT/PTs run by Corporation and private organisations offer bathing facility also. Every day on an average 250 men and 180 women use CT/PTs, across corporation, WAVES, and NGO run CT/PTs. Private CTPT, report 250 men and 50 women using their toilets on a daily basis.

in each toilet for disposal as the toilets have small plinth area. Women complained that despite several instructions, most users of community toilets either throw the napkins into the toilet, thereby clogging the drain or wrap it in paper and stuff it in the window sill, with a risk of it falling on the next user. Further, sanitary workers refuse to collect bins with sanitary napkins, thereby leaving them no choice but to burn them.

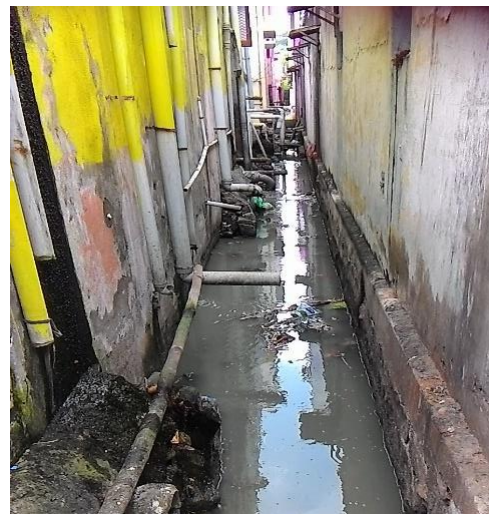
Figure 3.9: Open drains

'Best containment structure is one that removes the filtered waste water immediately. Example would be a pipeline from the containment structure to an open drainage system. The waste water should not be stored; it should go outside so that sludge will remain and can be cleaned every five years. There is no use in building a tank if there is no option for removing water from containment structure' – Mason from Tiruchirappalli.

However, community members are aware of the negative consequences of draining water from onsite systems in to open drains. For one, it promotes defecation of toddlers in open drain, which then increases their chances of coming in contact with fecal sludge and increases bad odour. Further, since the drains are constructed without considering topographical slope, water does not flow properly. The situation is further compounded by improper waste disposal into the drain. With infrequent drain cleaning and de-silting, drains get blocked and facilitate mosquito breeding. Even when garbage is cleared from drains, it is kept aside and not cleared immediately.

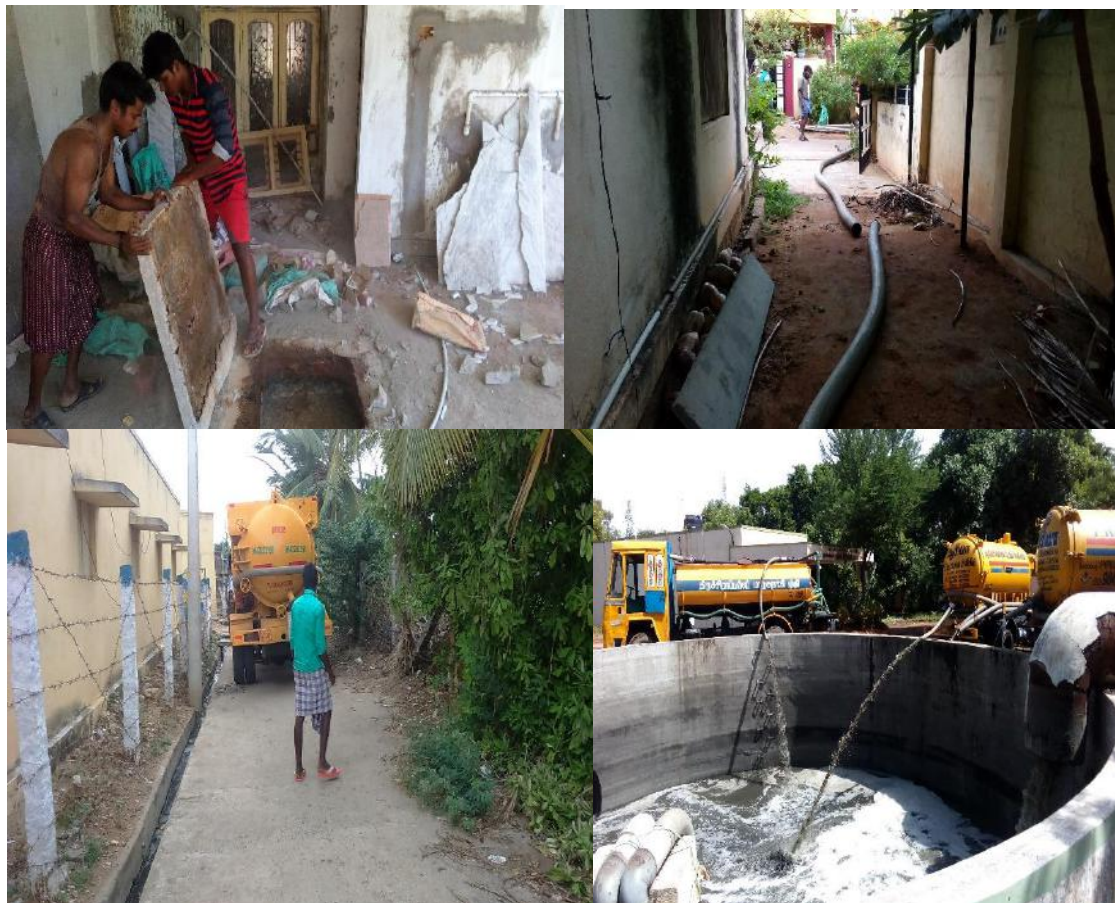
Figure 3.11: Collection and disposal of fecal sludge from households in Tiruchirappalli

Households largely seem to be unaware about where the fecal sludge is disposed once it has been removed from their on-site systems. Only nine households knew where the fecal sludge is emptied in the river or stream (4), buried on land (1) and dumped in farms (4).

Two de-sludging proprietors report transporting matter via tankers to the Sewage Treatment Plants (STPs) and neither of them mentioned facing any problems. Both proprietors report to operate well maintained tankers which are leak proof. They dispose the fecal sludge at the STPs as that is the prescribed site by the law. Both drivers reported using the Panjapur STP and also mentioned the existence of a second STP (one driver recalled that it was located at Jamamal College and the other, at Anna Stadium). Secondary research indicates that these are actually two decanting sites which are run by the Corporation for the collection of fecal sludge in case of Panjapur STP is not accessible. This narrative is however, not consistent with observations from other stakeholders.

Most containment units observed were septic tanks with provision for access. Operators had to break open the manhole with crowbar and improvised tools such as drilling machines. Tankers used for de-sludging were professionally designed, with ladder, storage space for pipes and tools. Tank capacity ranges from 4,000 to 10,000 litres and are rubber lined for long life. Suction piper are up to 100 feet in length, with operator using couplers for joints. Many operators work bare chested.

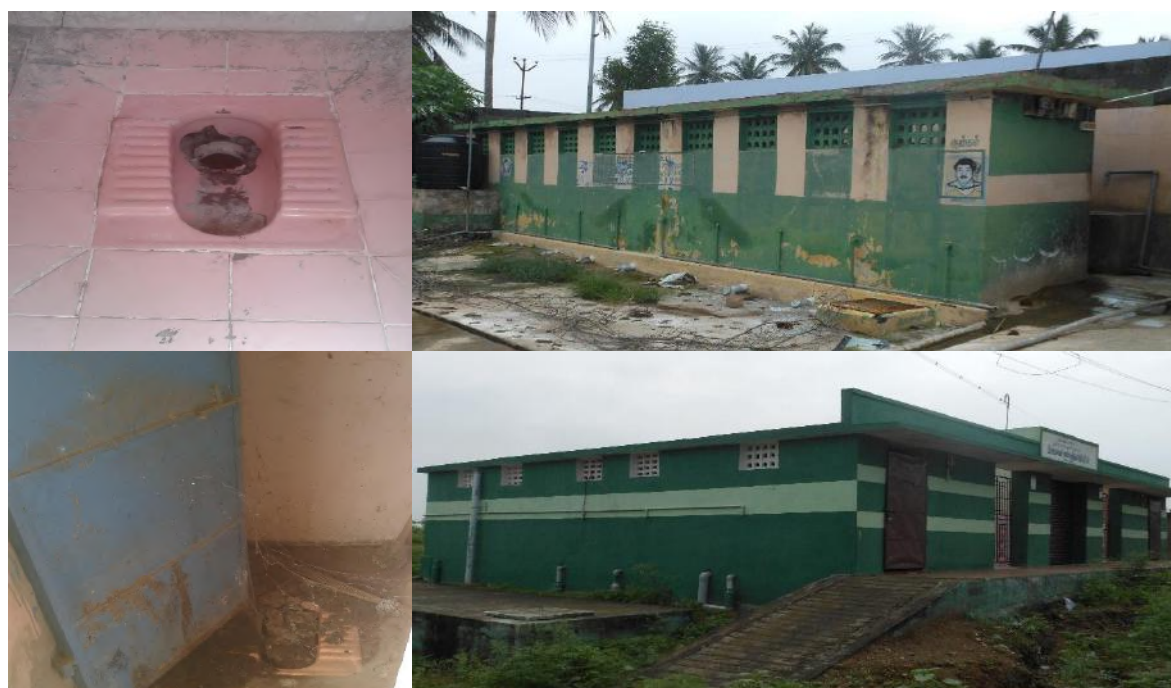
Figure 4.3: Community toilets in Town Panchayats

Despite the growing demand, the quality of community toilet maintenance in TPs leaves a lot to be desired. Common complaint is that insufficient number of toilets to serve the user population leads to long queues in the morning. This is exacerbated in TPs with those who have individual toilets also preferring to use community toilets. Among the main problems reported in using community toilets, were long waiting hours, lack of availability of water and lack of cleanliness.

Across all the locations, community groups expressed strong displeasure with the current management and need for improvement in management of community toilets, their infrastructure, cleanliness and maintenance. For one, there is no designated person to maintain the toilet due to lack of manpower and toilets are cleaned mostly once in a day by the sanitation workers. Children stated that the doors are broken, there are no buckets, and water taps are damaged. In the absence of water taps inside the toilets, users need to carry water for cleaning. None of the toilets have exclusive seat for aged people or children. However, community groups report approaching town panchayats and ward councillors only when the sanitation workers failed to address the water clogging and blockage in septic tank. Not surprisingly, user experiences of community toilets are not highly rated.

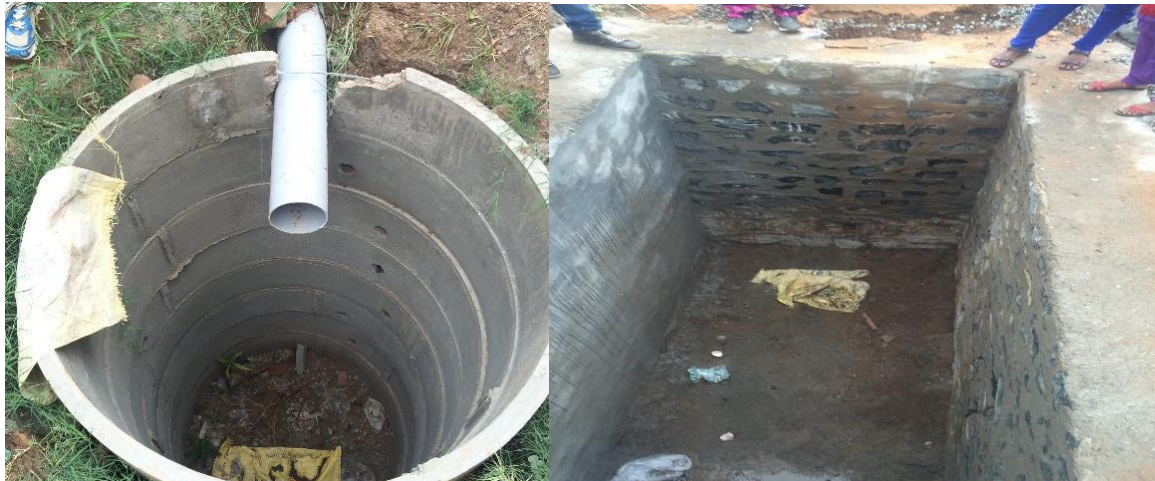
Figure 4.9: Containment structures in Town Panchayats

'Most of the earthen tiles houses (poor households) use pits while the RCC houses have Basalt septic tanks. The primary reason for this difference is the price point of the containment structure. The pits are largely constructed under the government subsidy whereas the septic tanks tend to be self-funded' - Mason, PNP

Builders were against the use of pit structures due to their short life span. ‘Pit structures are made up of cement and sand, and low cost iron wires are used to hold the cement and sand together. In order to make profit, the manufacturers of pit-ring structures use less cement and more sand which shortens the life of the structure. Moreover, the pit-rings stay immersed in black water as soon as the structure is filled since percolation only takes place from the bottom. This causes the rings to erode and lose their strength quickly.’

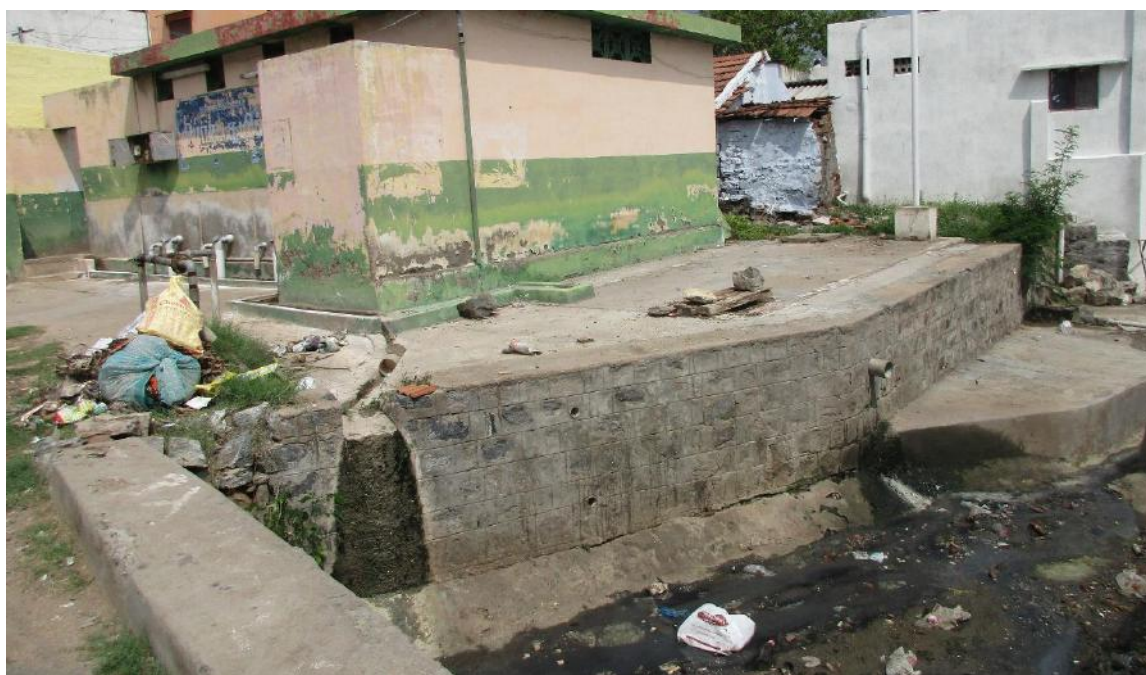
Figure 4.15: Household wastewater connected to open drains in Town Panchayat

Grey water from kitchen is mainly disposed-off in to the drain directly across both slums and non-slums in NNP and PNP. In the slums in NNP however, it is also used in the kitchen garden (16 per cent) or sent to a separate soak pit (14 per cent). Waste from bathrooms is also disposed-off in a similar as kitchen waste.
