SCALING-UP IMPROVEMENTS TO COMMUNITY TOILETS: A PILOT DEMONSTRATION AT RMS COLONY, TIRUCHIRAPPALLI

October 2022

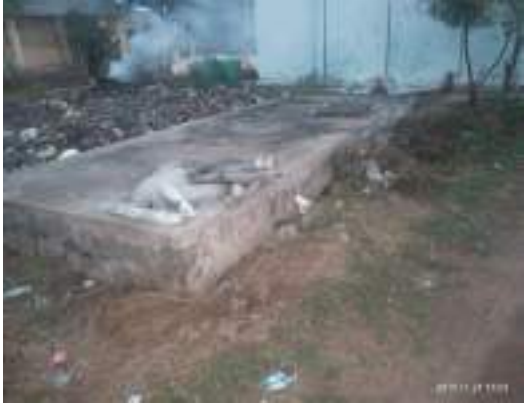
Figure 1.2: Septic Tank	Figure 1.3: Overflow of Septage from Septic Tank Accumulated Near to Inlet Side

The containment system of the community toilet at RMS Colony was lacking disposal arrangements, had leaks and damage in the access cover(manhole). The lack of disposal arrangements caused the septic tank to overflow, which led to frequent closures of the CT. To control overflow from the septic tank, TCC de-sludged the containment once in two days. TCC's indirect costs to de-sludge the CT were Rs. 1.08 lakhs per year.

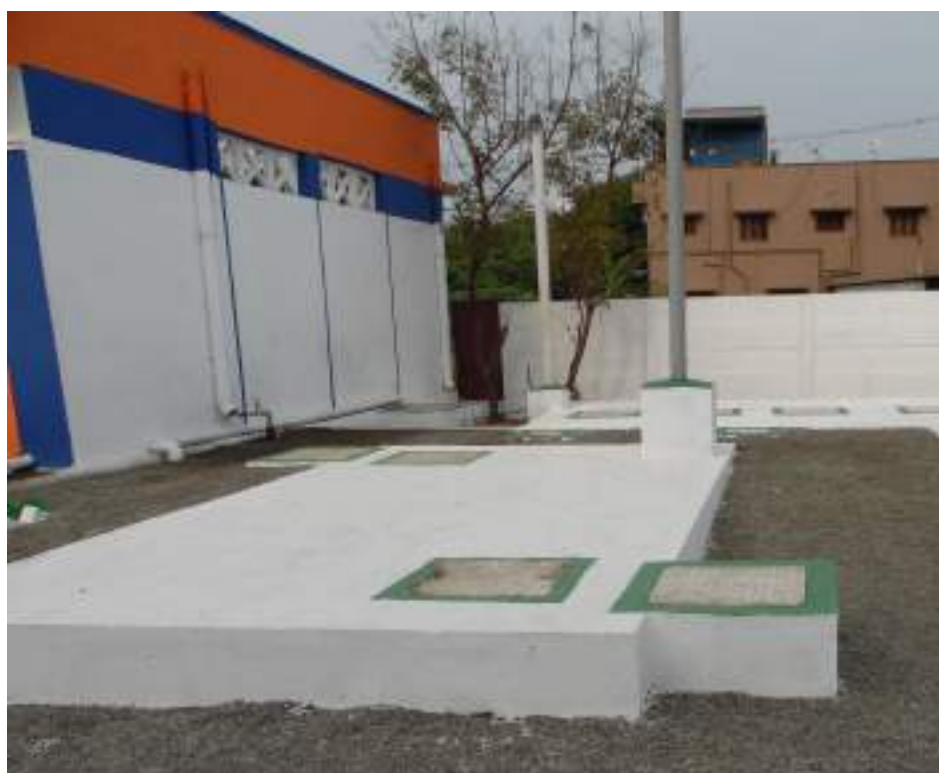
Figure 6.2: Primary Settler After Construction

The construction of the primary settler started with measuring and marking the level and layout. Safety measures were followed during the construction work. Following the excavation process, the Plain Cement Concrete (PCC) applied and after construction of bottom floor with Reinforced Cement Concrete (RCC), outer wall, baffle wall, and plastering inside the tank works were completed. Once the roof slab was constructed, a hydrostatic test was conducted. The primary settler was used as the temporary containment system until the septic tank was refurbished. The septic tank was opened and de-sludged after diverting the wastewater to the primary settler. As a precautionary measure, the sides of the septic tank were excavated to a depth of 1 m before de-sludging to prevent earth pressure.

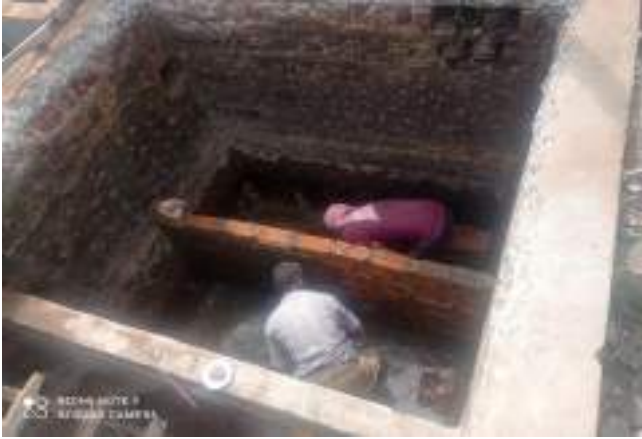
The existing septic tank is converted into an improved septic tank. Since the septic tank had leakages, it was continuously dewatered until masonry work was completed. Two baffle walls (Figure 6.3) were constructed along with the existing two baffle walls and a filter bed (perforated RCC slab) was provided to place the filter media. T-pipes were placed at the inlet of each chamber to prevent scum from passing between chambers and extended up to the bottom of the tank to increase the digestion process and reduce the velocity of flow. The existing septic tank is converted into improved septic tank (Figure 6.4) which consists of the following units.

Figure 6.3: Construction of Baffle Wall Inside the Existing Septic Tank	Figure 6.4: RCC for Roof Slab – Improved Septic Tank

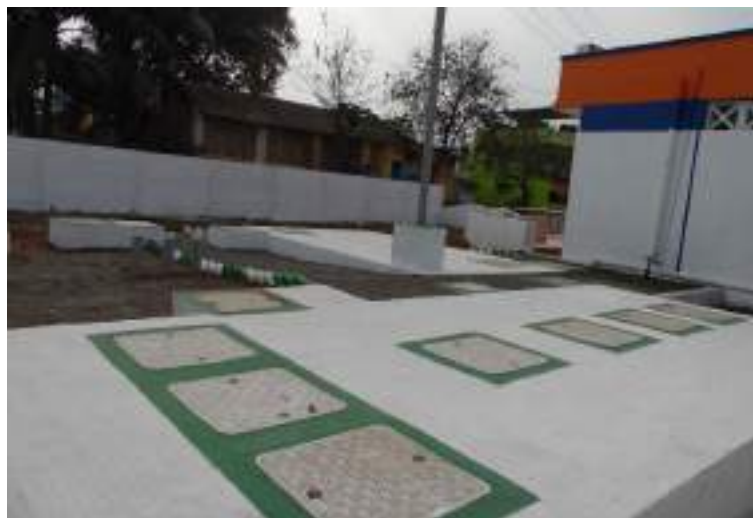
Figure 6.5: Improved Septic Tank After Construction

The support walls and pre-cast perforated slabs were used as a platform for the filter media. Effluent from this anaerobic filter was sent to the dispersion trench. Following a hydrostatic test, the system was commissioned (Figure 6.5), and the temporary provision was discontinued.

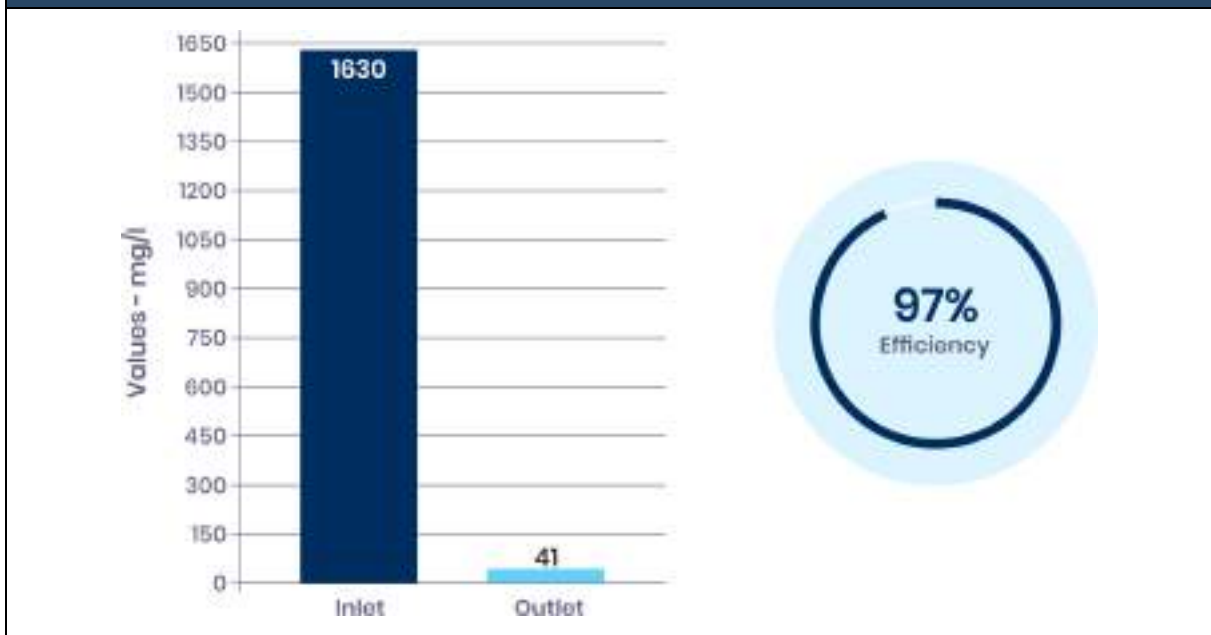
Figure 7.2: RMS Colony Containment System Treatment Performance - BOD

The quality of the treated water in the containment is monitored from February 2021 to February 2022. The results of the organic pollutant load in the treatment system shows the biological treatment of the improved septic tank is effective. The high concentration of COD and BOD in the Primary digester significantly reduced after the biological treatment process in the Anaerobic baffled reactor and Anaerobic Filter.
