QUALITY ASSURANCE SUPPORT FOR IMPLEMENTATION OF FECAL SLUDGE TREATMENT PLANTS IN TAMIL NADU

October 2020

Quality Assurance Support for Implementation of Fecal Sludge Treatment Plants in Tamil Nadu

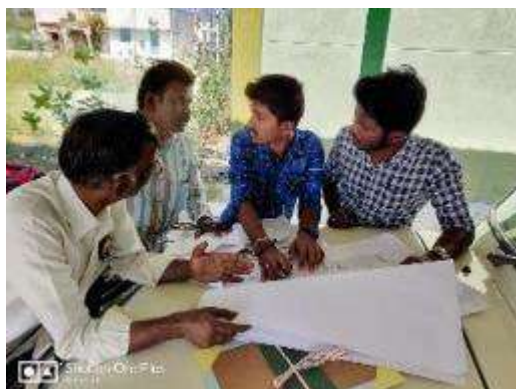
Figure 3.1: Detailing of the type design

The TSU provided the type design(s) for the FSTP and were finalised in consultation with the CMA and DTP. Typeset drawings for 20 KLD, 30 KLD AND 40 KLD FSTPs were shared with the ULBs to obtain technical and administrative sanctions to commence work. Three significant revisions were made to the typeset drawings based on inputs from experts and learnings from implementing the designs in the field. Technical experts of regional engineering colleges prepared structural drawings by referring to the typeset drawings to customise the design based on land availability and field characteristics of the respective FSTPs. All ULBs were given assistance to fix the hydraulic profile of the treatment plant. The TSU also shared a format to obtain PCB clearances so that ULBs could apply for the CTE certificate.

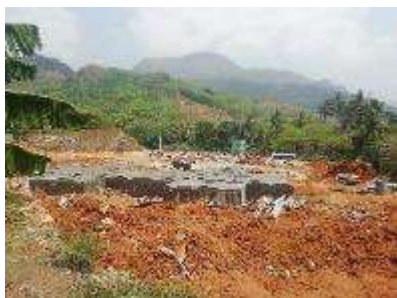
Table 3.1: Challenges in stage I			
Sl. No.	Challenges in stage I: Pre-construction	Site-specific examples	Solutions
3	<p>Hilly terrain</p> <p>Figure 3.5: FSTP site with difficult terrain and unstable soil</p>

<p>Source: TNUSSP, 2020</p>	<p><i>Padmanabhapuram:</i> The land identified by the ULB was on a hilly terrain. Solid waste was dumped on one part of the site which had consolidated with the soil over several years. Therefore, it was not possible to proceed with the typeset design. The QA team found that construction of all the Sludge Drying Beds side by side was not possible.</p>	<p>The QA team provided a site-specific customised design, where it requested the ULB engineers to construct a bigger single bed, instead of two beds. The QA team also instructed the ULB to lay Wet Mix Macadam and then lay footings with grade beam connection to enhance stability.</p> <p>Similarly for Stabilisation Reactor (SR), it was observed that having two SR for a 20-KLD plant next to each other with a gap of 2 m was not possible due to space constraints. Hence, the QA team requested the ULB to combine the two SRs and have one big SR.</p>

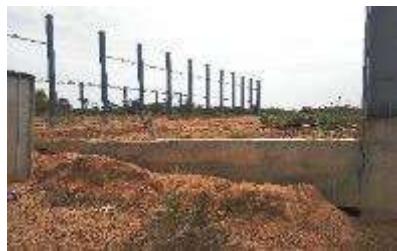
4	<p>Inappropriate soil conditions</p> <p>Figure 3.6: FSTP site with an existing structure</p>

<p>Source: TNUSSP, 2019</p>	<p>Several sites</p>	<p>In such cases, alternative locations were suggested with suitable soil conditions.</p> <p>Or in some cases, an appropriate structural drawing was suggested based on the soil test reports.</p>

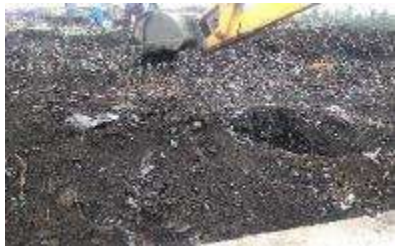
Sl. No.	Challenges in stage I: Pre-construction	Site-specific examples	Solutions
5	<p>Soil characteristics</p> <p>Figure 3.7: FSTP site with instable soil</p>

<p>Source: TNUSSP, 2019</p>	In some sites, the soil had large volumes of solid waste which threatened the stability of the soil.	In such cases, ULBs were requested to refill soil.
6	<p>Slope related issues</p> <p>Figure 3.8: FSTP located in a hilly terrain</p>

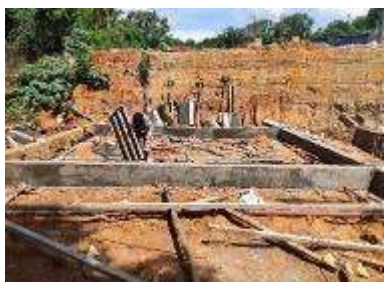
<p>Source: TNUSSP, 2019</p>	ULBs with hilly terrain.	Appropriate structural drawings were suggested based on the challenges. For instance, additional retaining wall was suggested in hilly areas.
7	<p>Solid waste dumped at site</p> <p>Figure 3.9: FSTP site covered with municipal solid waste</p>

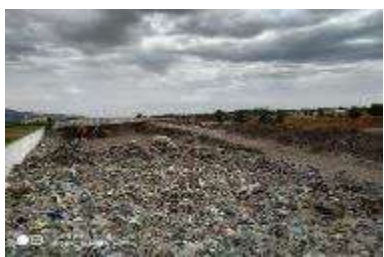
<p>Source: TNUSSP, 2019</p>	In many ULBs, solid waste was found to be more than 4-5 feet deep. It took five to six months to clear it which led to severe delays in the construction of the FSTP.	The QA team requested ULBs to not wait until all the waste was removed. Instead, they were requested to remove waste from one portion of the site and commence excavation work or any related work in the other portions. Though it was initially hard to convince the ULBs to carry out this task, they eventually understood and commenced work.

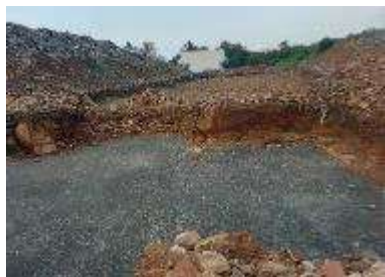
Table 3.2: Challenges in stage II			
S. No.	Challenges in stage II	Site-specific examples	Solutions
1	<p>Presence of rocks during excavation</p> <div> <p>Figure 3.10: FSTP site with rocky soil</p>

<p>Source: TNUSSP, 2019</p> </div>	<p>Workers encountered rocks during excavation in many sites, stalling the digging process. Due to these rocks, the site-specific levels that the QA team initially provided could not be achieved.</p>	<p>If the level changes for one of the components in the FSTP, then the levels must be changed for the successive components. The QA team helped change the levels of all the components so work could commence on time.</p>

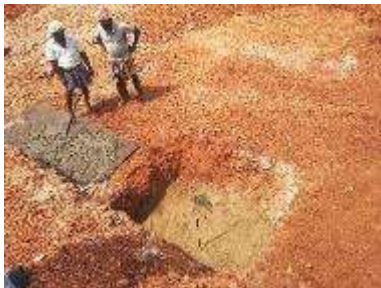
S. No.	Challenges in stage II	Site-specific examples	Solutions
2	<p>Difficulties in maintaining the standard levels during excavation</p> <p>Figure 3.11: Improper excavation</p>

<p>Source: TNUSSP, 2019</p>	<p>After the QA team provided the standard levels, several ULBs started the excavation process without paying due attention to these levels. This resulted in the excavator either digging too much or too less.</p>	<p>The QA team advised the ULB to dig more at sites where less than optimum levels of digging had taken place. However, in sites where too much digging had taken place, the QA team requested the ULBs to increase the thickness of the PCC layer and the base slab. ULBs were also requested to not refill with soil, leading to structural weakness.</p>
3	<p>Space constraints</p> <p>Figure 3.12: Insufficient working space</p>

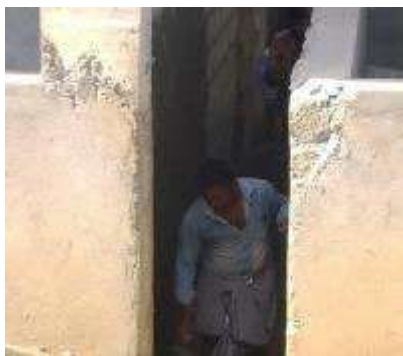
<p>Source: TNUSSP, 2020</p>	<p>In many ULBs, excavation work commenced for both sides of the Sludge Drying Beds simultaneously which restricted space for worker movement as well as for trucks to reach the end of the site and unload raw materials.</p>	<p>After observing these challenges at several sites, the QA team requested the new ULBs to first start work on one SDB and use the rest of the space to unload materials and have unrestricted working space.</p>

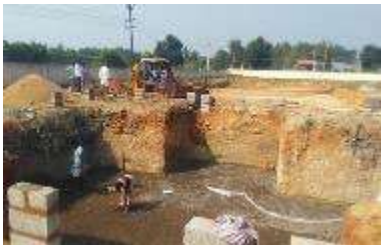
Table 3.2: Challenges in stage II			
S. No.	Challenges in stage II	Site-specific examples	Solutions
4	<p>Barricading</p> <p>Figure 3.13: Unsafe/Open excavation</p>

<p>Source: TNUSSP, 2019</p>	<p>Deeper excavation requires barricading for safety and protection. However, most ULBs did not put-up barricades or warning signs at the construction sites.</p>	<p>The QA team continuously emphasised the importance of barricades for the safety of the workers. They were also requested to place signboards at appropriate locations.</p>
5	<p>Compaction</p> <p>Figure 3.14: FSTP site spotted with insufficient compaction</p>

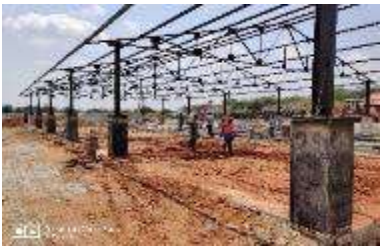
<p>Source: TNUSSP, 2019</p>	<p>Many ULBs laid the PCC right after excavation, skipping compaction, a crucial process.</p>	<p>The QA team visited the sites to check for compaction before the ULBs laid the PCC. ULBs were also mandated to inform the QA team before laying the PCC.</p>

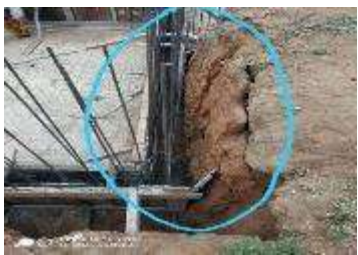
S. No.	Challenges in stage III	Site-specific examples	Solutions
2	<p>Shuttering</p> <p>Figure 3.16: Improper shuttering</p>

<p><i>Source: TNUSSP, 2020</i></p>	<p>In some sites, ULBs skipped wooden shuttering and directly poured the concrete. In Padmanabhapuram, proper support was not provided while shuttering. When concrete was laid, the entire structure gave away, creating a hollow space on the surface.</p>	<p>The QA team oriented the ULB engineers about the importance of shuttering and explained that improper shuttering could result in issues such as formation of honeycombs and concrete bulging. The structure could also collapse while laying concrete, posing serious challenges.</p>
3	<p>Cover blocks</p> <p>Figure 3.17: Absence of cover blocks</p>

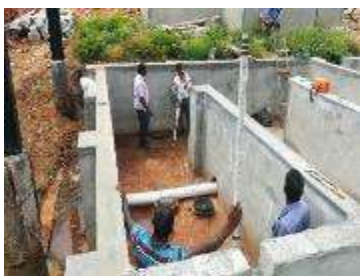
Table 3.4: Challenges in stage IV			
S. No.	Challenges in stage IV	Site-specific examples	Solutions
1	<p>Core-cutting method not followed properly and challenges in fixing pipe levels</p> <p>Figure 3.21: TSU assisting in fixing pipe levels</p>

<p>Source: TNUSSP, 2020</p>	<p>During each site visit, the QA team provided the levels for each of the components to fix the pipes. However, it during follow-up visits the team observed that several ULBs misplaced the levels and did not cut properly.</p> <p>In most ULBs, the QA team repeatedly encountered errors in the pipe levels. Despite fixing the pipe levels, ULBs made mistakes during the cutting process.</p>	<p>In such cases, they were advised to fill the holes and redo the cutting. However, re-cutting is not ideal because, during the cutting process, the steel rods also get cut and too many cuts could impact the strength and stability of the modules in the long term.</p>

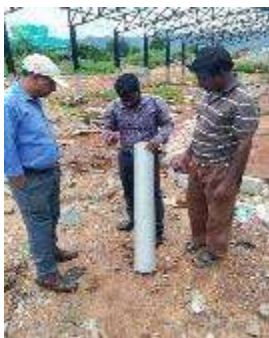
S. No.	Challenges in stage IV	Site-specific examples	Solutions
2	<p>Quality of pipes</p> <p>Figure 3.22: TSU inspecting quality of pipes</p>

<p>Source: TNUSSP, 2020</p>	<p>Proper specifications for pipe quality were given to the ULBs. ULBs were supposed to procure UPVC pipes of a certain quality and thickness for piping. However, many ULBs were found using inferior quality PVC pipes for construction. Such PVC pipes lacked strength and became brittle or broke over time.</p>	<p>In such instances, the QA team explained the importance of adhering to the specifications without compromising on quality. In some cases, like Kangeyam, superior quality pipes were used which exceeded the standards prescribed in the specifications. The QA team explained that this too was unnecessary.</p>
3	<p>T-pipes not used as recommended</p> <p>Figure 3.23: TSU inspecting pipe connections</p>

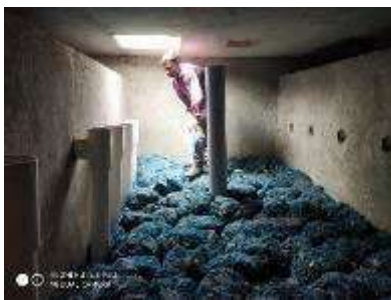
<p>Source: TNUSSP, 2020</p>	<p>The QA team had specified the usage of T-pipes in the revised structural drawings for ease of O&M in the different modules. However, during field visits, the QA team observed the usage of elbow/bend pipes. Once fixed, it was very difficult to replace these elbow/bend pipes. T-pipes were useful in clearing blockages unlike elbow/bend pipes.</p>	<p>The QA team insisted on using T-pipes to avoid irreversible O&M issues in the long run.</p>

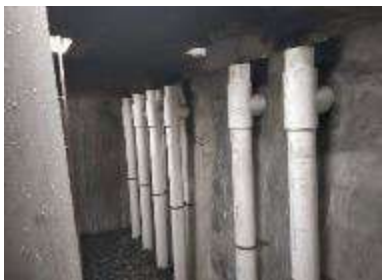
S. No.	Challenges in stage IV	Site-specific examples	Solutions
4	<p>Absence of UPVC clamps</p> <p>Figure 3.24: Pipes supported with SS clamps</p>

<p>Source: TNUSSP, 2020</p>	<p>In the Stabilisation Reactor, the length of the chamber was almost 10 m and the pipe connections were very long. In such cases, the pipes needed to be supported well with the help of UPVC clamps that held the pipes to the walls. While UPVC clamps were recommended for use, in most places the QA team observed the usage of steel clamps. Steel clamps corroded easily.</p>	<p>As and when the QA team observed the usage of steel clamps, they advised the ULBs to replace them with UPVC clamps. However, in certain places where the steel clamps were already fixed, it was challenging to remove and replace them with UPVC clamps.</p>
5	<p>Angular cuts in pipes recommended but not followed</p> <p>Figure 3.25: Angular cuts in T-pipes</p>

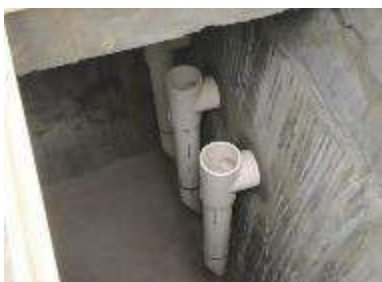
<p>Source: TNUSSP, 2020</p>	<p>The QA team had recommended an angular cut at the base of the T-pipes to achieve a larger diameter so that septage could flow easily through the pipes. However, most ULBs failed to understand its importance.</p>	<p>After proper orientation, most ULBs understood the relevance of angular cuts and started implementing it.</p>

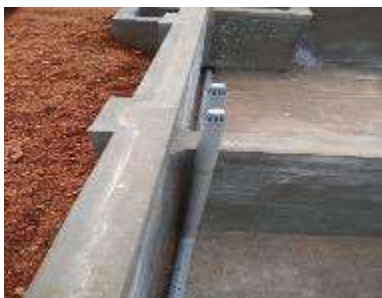
Table 3.4: Challenges in stage IV			
S. No.	Challenges in stage IV	Site-specific examples	Solutions
6	<p>Vent pipes for anaerobic modules</p> <p>Figure 3.26: Vent pipes in treatment modules</p>

<p>Source: TNUSSP, 2020</p>	While vent pipes were to be fixed in all the anaerobic modules like Stabilisation Reactor and Integrated Settler-Anaerobic Filter, some ULBs did not provide this despite orientation.	The QA team insisted on the usage of vent pipes in all anaerobic modules.
7	<p>Pipe exposure</p> <p>Figure 3.27: Exposed drainpipes</p>

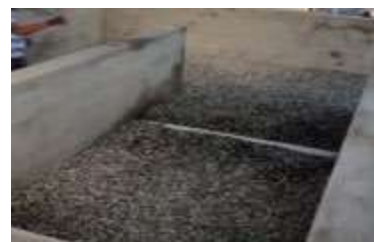
<p>Source: TNUSSP, 2020</p>	When the distance between the two modules is very long, there is a threat of pipes getting exposed. In Tirumangalam, the distance between IS-AF and PGF was more than 2 m. Hence, the pipes were completely exposed and visible above the ground level.	The QA team noticed this during their fortnightly visits and requested the ULB to conceal the pipes by filling it up with soil till the level of the pipes.

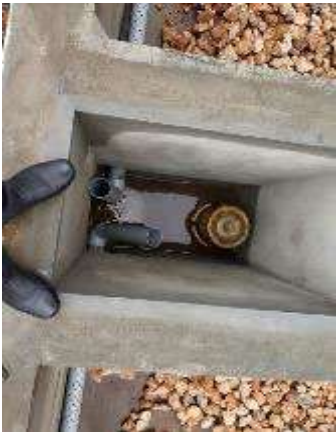
Table 3.4: Challenges in stage IV			
S. No.	Challenges in stage IV	Site-specific examples	Solutions
	<p>Figure 3.28: Swivel pipe installation</p>

8	Swivel pipes: Improper installation	<p>The ULBs were instructed to provide movable swivel pipes at the outlet of the PGF chamber. However, most ULBs did not understand the relevance of swivel pipes and failed to install them.</p> <p>The swivel pipes should be bent at a certain to maintain</p>	<p>After the QA support team explained how the swivel pipes helped in maintaining the water levels in the PGF and ensured adequate retention time for treatment in PGF, the ULBs immediately installed the pipes.</p> <p>The QA support team requested the ULBs</p>

<p>Source: TNUSSP, 2020</p>	the water level in the HPGF, which could be confusing for the ULBs to understand during routine O&M.	to provide a 'paint mark' on the wall adjacent to the pipe. Similarly, in SDBs too, the QA team requested ULBs to provide paint markings to indicate the maximum level of sludge that each SDB could receive.
9	<p>Perforations in the pipe: Not cleaned and level drops not maintained</p> <p>Figure 3.29: Improper perforations</p>

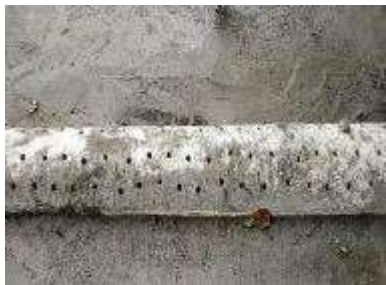
<p>Source: TNUSSP, 2020</p>	<p>Perforated pipes were fixed within the Sludge Drying Beds. After the perforations were made in the pipes, they needed to be cleaned to clear all the clogged particles.</p> <p>The level drops in the pipes connecting the drainage must be maintained. For instance, in Kovilpatti, it was noted that the level drops for one 10 KLD unit were not maintained resulting in a backflow. In the future, this could result in water stagnation and reduced efficiency of the plant.</p>	<p>The QA support team requested all ULBs to carry out this cleaning exercise.</p> <p>The QA team requested that corrections be made in the future construction in the 40 KLD plant in Kovilpatti.</p>

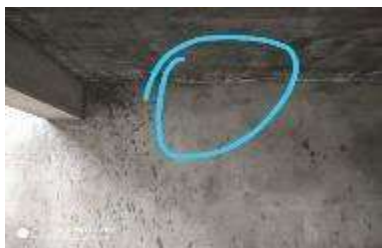
Table 3.5: Challenges in stage V			
S. No.	Challenges in stage V	Site-specific examples	Solutions
1	<p>Plastering: Waterproofing chemicals not added</p> <div> <p>Figure 3.30: Wall plastered without using waterproofing chemicals</p>

<p>Source: TNUSSP, 2020</p> </div>	<p>After concreting and curing is complete, plastering work must be undertaken for all the modules. During plastering, waterproofing chemical must be added in addition to the plastering mix. The QA team found that many ULBs did not add waterproofing chemicals while plastering.</p>	<p>Proper orientation was given to the ULBs regarding the importance of using waterproofing chemicals to protect the structure from damage when it came in contact with sludge/moisture.</p>

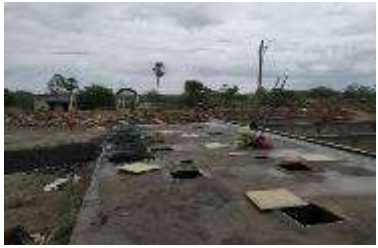
<p><i>Source: TNUSSP, 2019</i></p> </div>	Initially, manhole covers made of cast iron were planned to be used. Experts advised against the use of cast iron due to the risk of corrosion.	ULBs were advised to use FRP manhole covers.
10	Roofing: Polycarbonate sheets not used as recommended <div data-bbox="285 1384 730 1852" data-label="Image"> <p>Figure 3.37: Polycarbonate-GI sheet roofing in SDB</p>

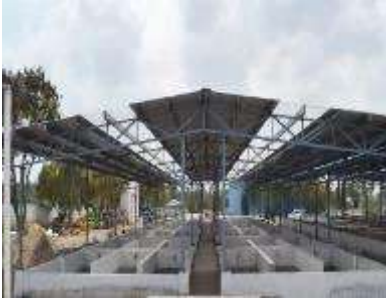
<p><i>Source: TNUSSP, 2019</i></p> </div>	ULBs were requested to use polycarbonate sheets for roofing for maximum penetration of sunlight. However, many ULBs chose GI sheets to save costs.	The QA team requested ULBs to use polycarbonate sheets in alternate rows while roofing.
